**AIR POLLUTION
ASPECTS
OF
TEPEE BURNERS**

AIR POLLUTION ASPECTS OF TEPEE BURNERS USED FOR DISPOSAL OF MUNICIPAL REFUSE

Thomas E. Kreichelt

U. S. DEPARTMENT OF HEALTH, EDUCATION, AND WELFARE
Public Health Service
Division of Air Pollution
Cincinnati, Ohio
September 1966

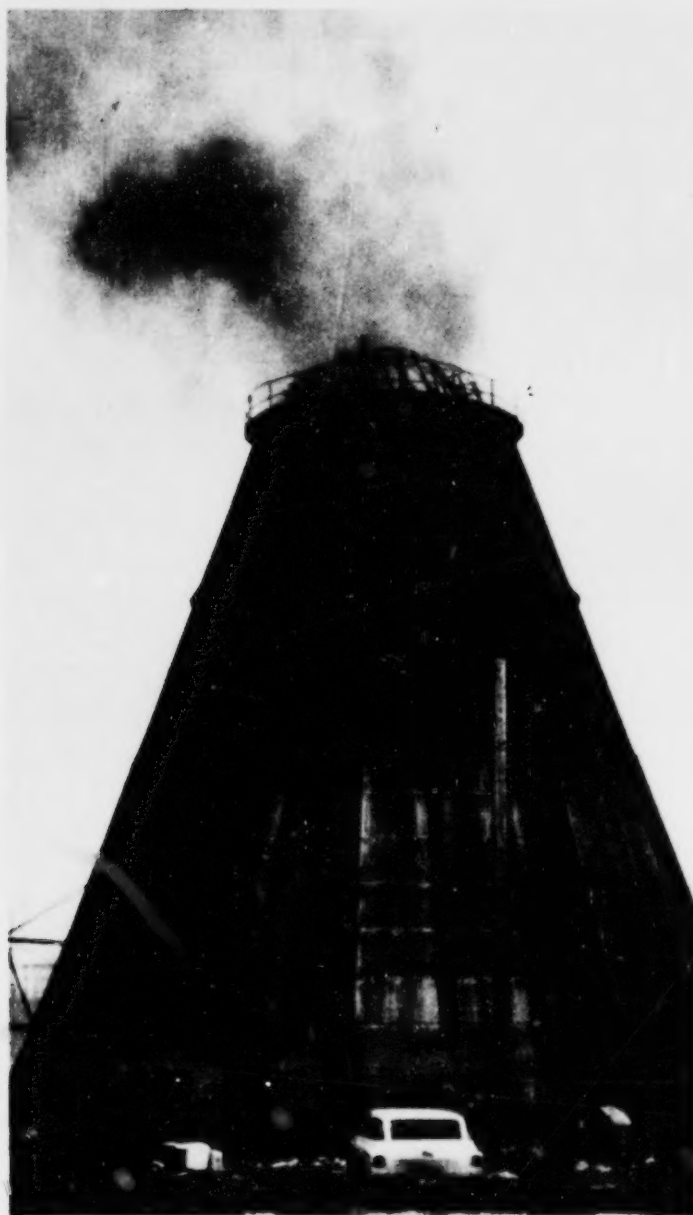
From an air pollution standpoint, the use of a dozer to feed refuse to a tepee is a very poor method (Figures 1 and 2). Table 3

Figure 1. Typical dozer-fed refuse burner. Charge is damp paper and wood. Note refuse guides attached to protect tepee entrance, prevent doors from being used.

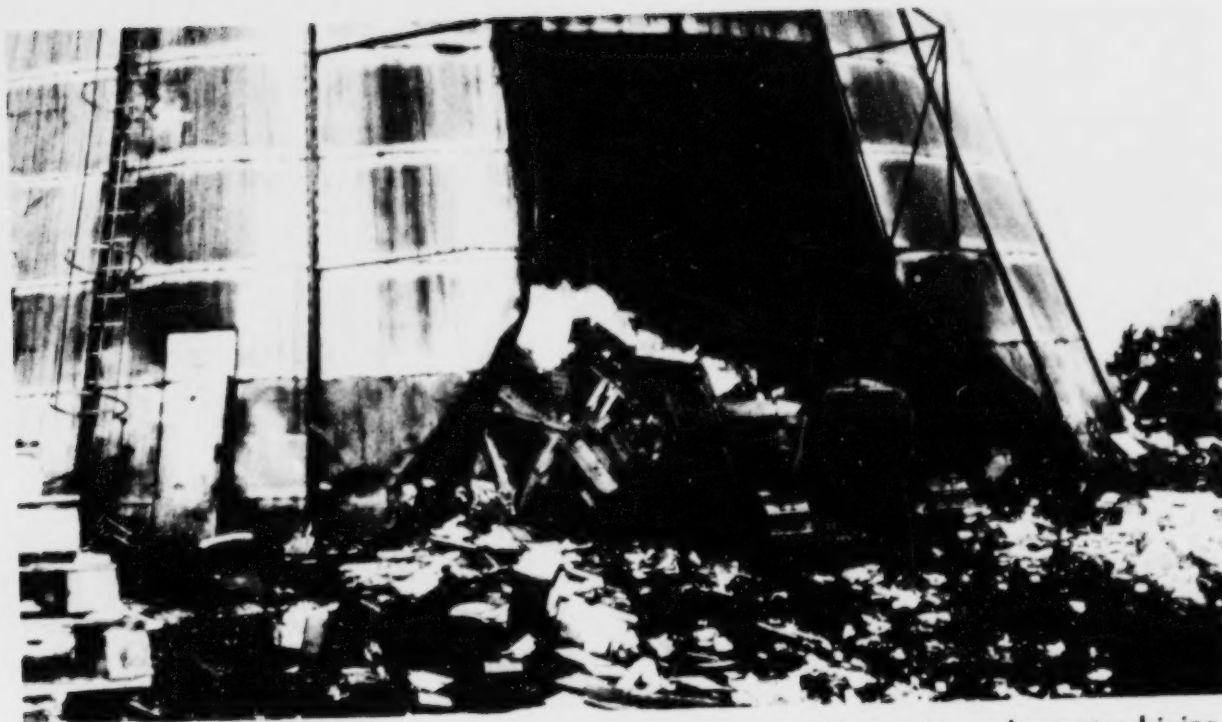
Figure 2. Tepee refuse burner being fed by dozer. Note torn door opening and operator driving unprotected into fire.

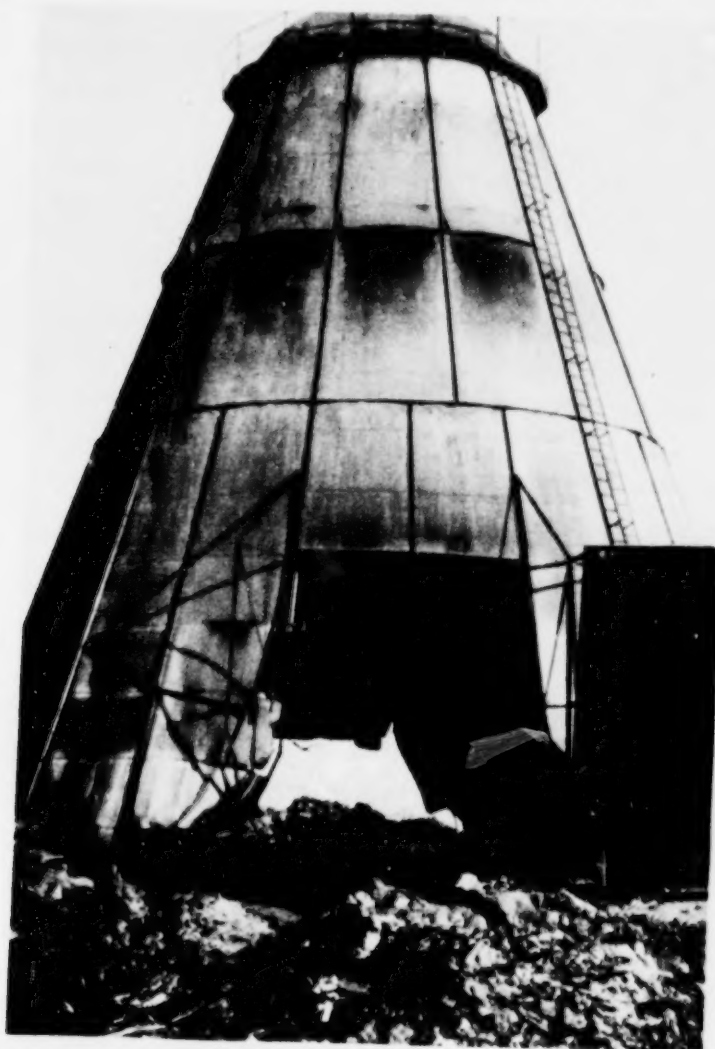
Figure 6. One of four dozer-fed tepee burners of comparable condition, each slightly over 2 years old.

the walls twist and crack from being overheated; second, the walls and doors are often hit and torn by the clean-out dozer because of limited dozer maneuverability. In addition, combustion efficiency is reduced because of the shortage of underfire combustion air. These factors result in greater smoke and fly-ash emissions. The burner operator then finds that the lifetime of the burner has dropped to 5 years or less. Note the age of the burners shown in Figures 5 and 6.

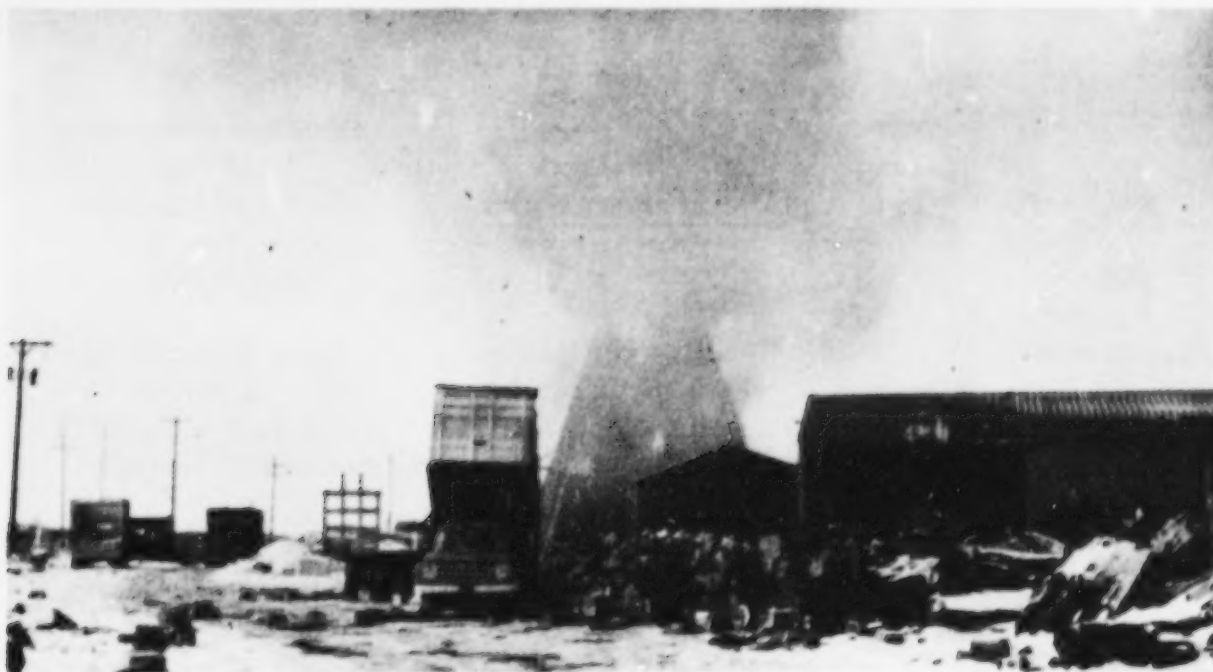
Composition of charge. Some materials should not be charged into a tepee refuse burner. Others should be charged only as a small percentage of a homogeneous mixture. Table 6 lists the types of materials that should and should not be fed into a tepee burner. All plastic, rubber, asphalt, and leather goods burn with a resulting smoke emission of a No. 5 Ringelmann or a 100 percent equivalent opacity regardless of the method of charge. Almost every experienced tepee burner operator questioned during the field observations felt that these materials should not be burned in a tepee. Most of the operators segregated this material and disposed of it by landfill. A typical example is shown in Figure 8 of a tepee burning plastic materials.

Figure 8. Emissions from burning plastic and polyvinyl chloride from electric wire.

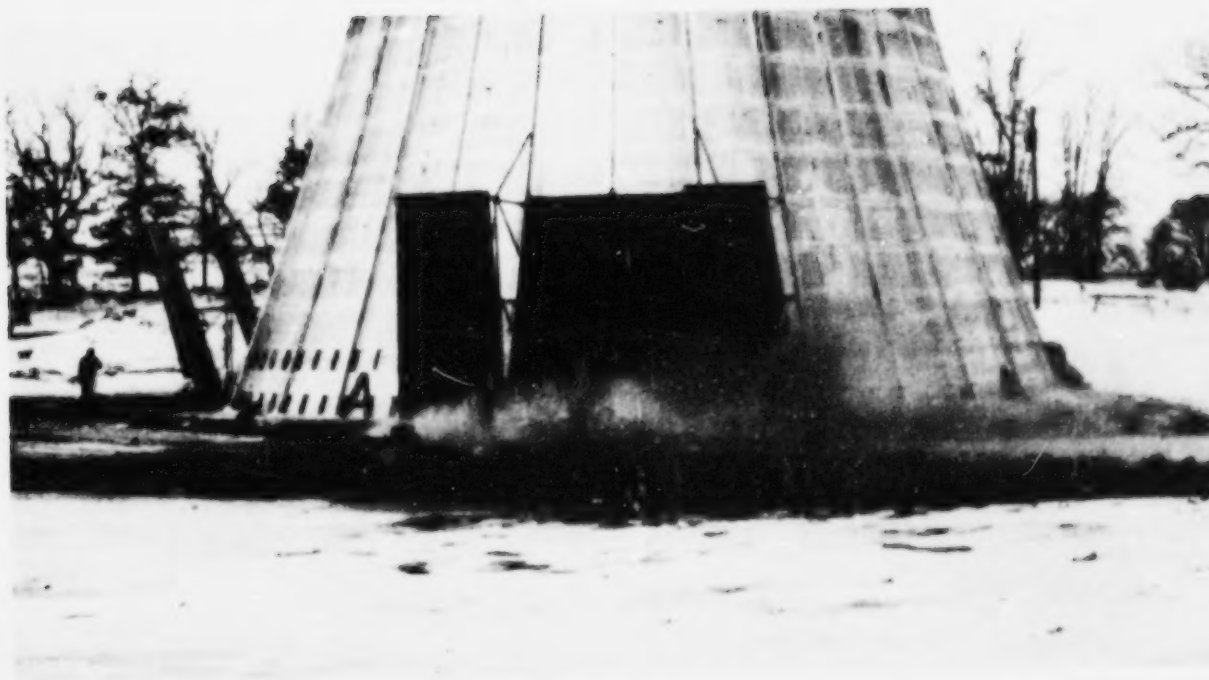
Only if the burner has not been overloaded or charged with wet material and if the forced draft through the pile has been sufficient, will the ash be cool during the clean-out operation. As it is removed from the burner, the cold ash may be sprinkled lightly with water to keep the dust emission to a minimum. Pictures of the clean-out operation, showing hot ash carried and pushed out (Figures 9 and 10), should be compared with the picture showing cold ash pushed from the burner (Figure 11).

Figure 11. Relatively cold clean-out of conveyor-fed tepee burner.

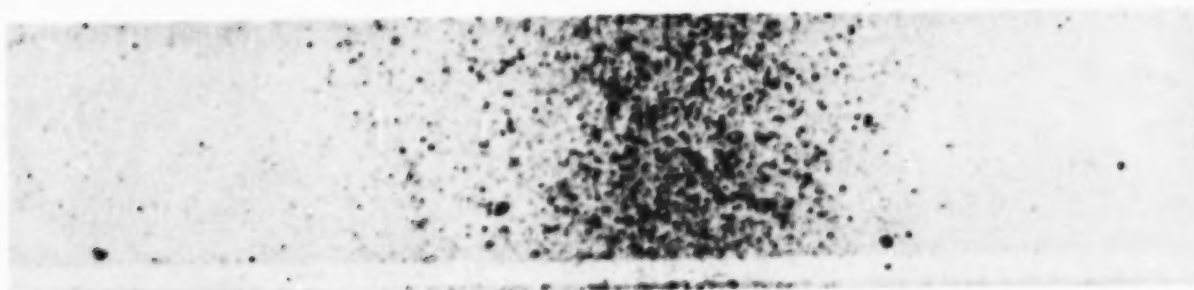
20-minute sample collected 260 feet downwind of burner.

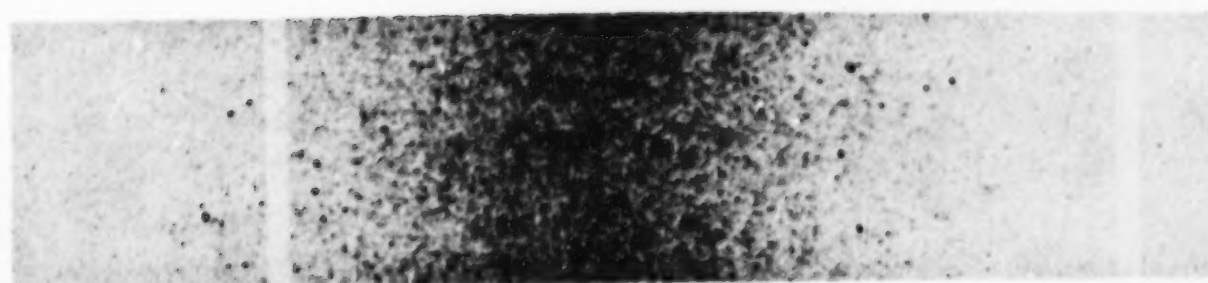
30-minute sample collected 200 feet downwind of burner.

Figure A-2. Directional sticky paper unwrapped from bottles showing particulate collected during the clean-out operation. Hot ash was carried from both burners by dozer scoop.

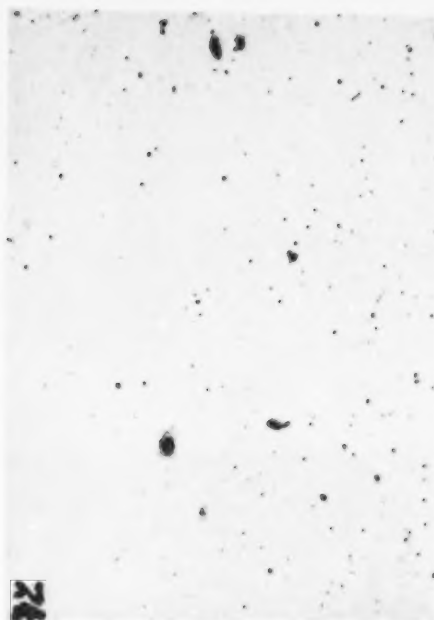
Sample collected 400 feet downwind of burner.

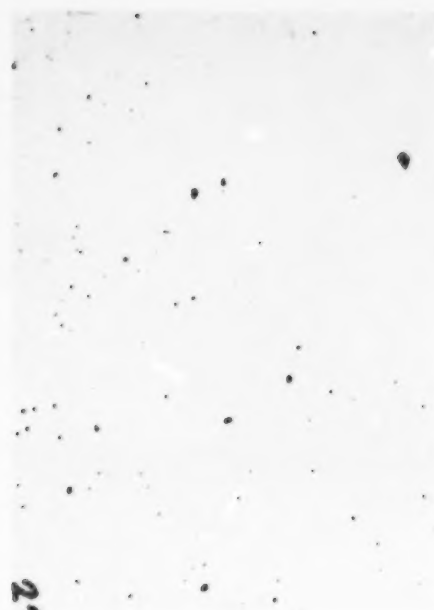
Sample collected 600 feet downwind of burner.

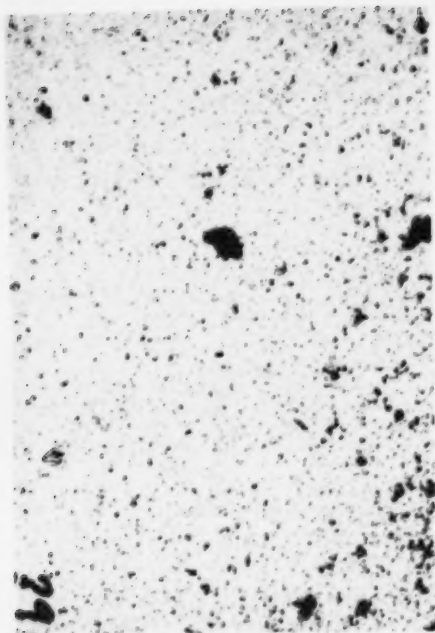
Sample collected 1,000 feet downwind of burner.

Figure A-3. Horizontal sticky paper samples showing particulate collected in 5 hours at various distances downwind of conveyor-fed refuse burner. Scale is full size.

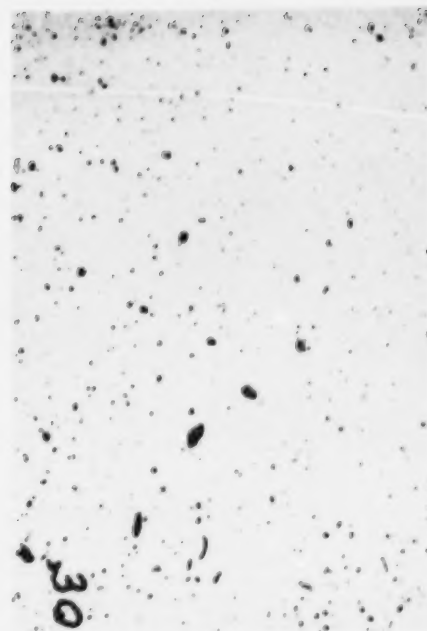
Sample collected 220 feet downwind of burner.
